Craig Farmer Inspections, LLC

Inspection reference: Laurel Kerr 2020

Thursday, July 23, 2020

7286 Revilo Point Rd.
Hayden ID 83835

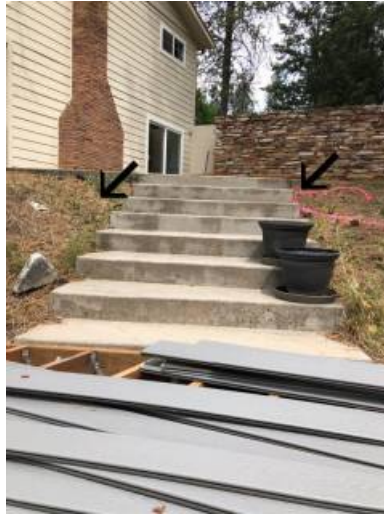
5.8 PHOTOS:

5.7 REPAIRS\COMMENTS: Concrete. By code needs a railing.

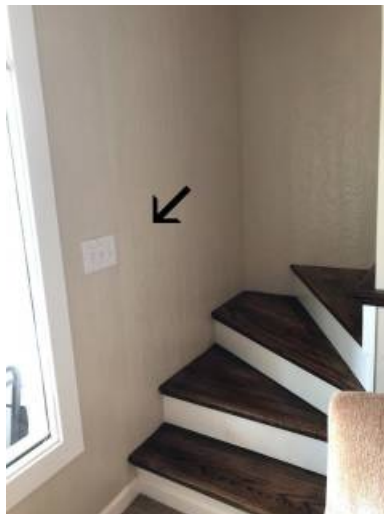
8.5 PHOTOS:

8.4 REPAIRS/COMMENTS: By code needs hand railing.

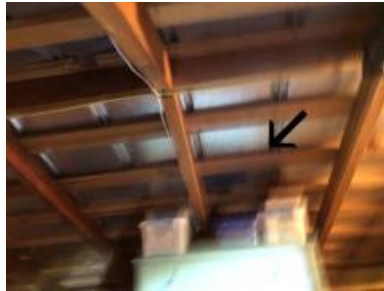
11.3 PHOTOS:

No sheathing on the roof. A lot the houses are built this way. See pictures. Recommend installation in between rafters on the roof. The way it is built currently there is a lot of heat loss.

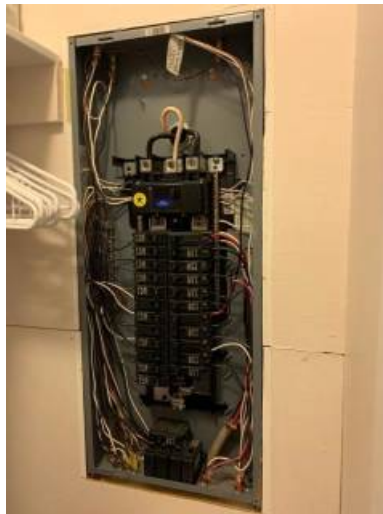
12.3 *PHOTOS:*

12.2 *REPAIRS/COMMENTS:* Breaker Box is in a closet. This is a code violation. Cannot have a Panel in a closet.

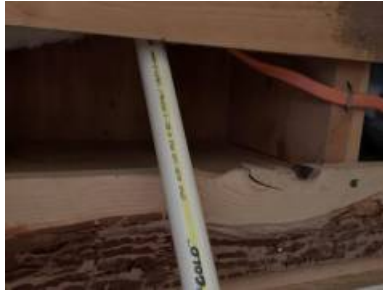
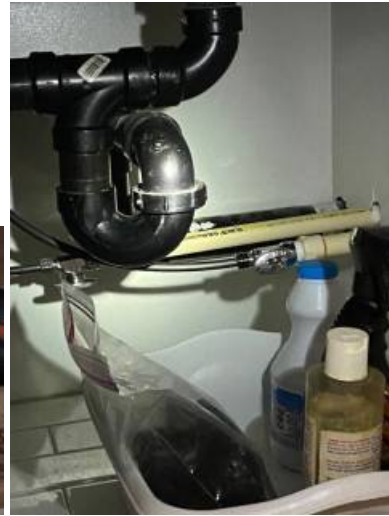
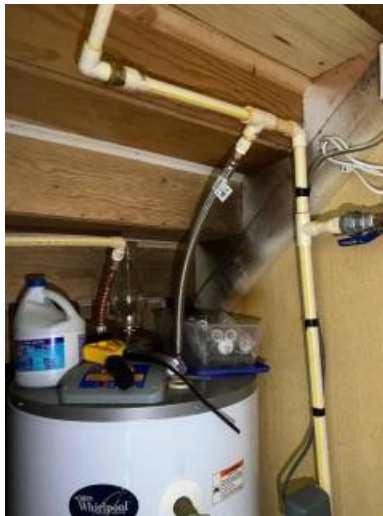
Note: The plumbing was replaced with CPVC. It is not as durable and long lasting as PEX. This needs to be replaced as CPVC is not long lasting To change this out will require opening up the downstairs ceiling and possibly some of the walls to access the plumbing as well.

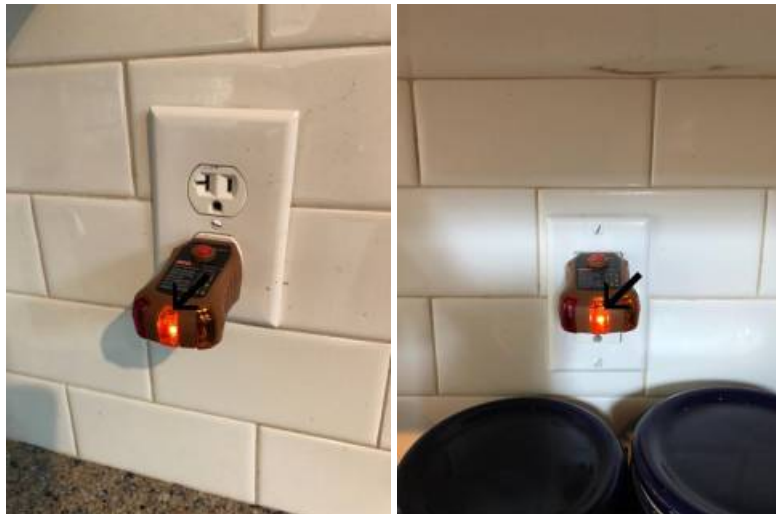
15.4 PHOTOS:

15.3 REPAIRS/COMMENTS: Open grounding problem.

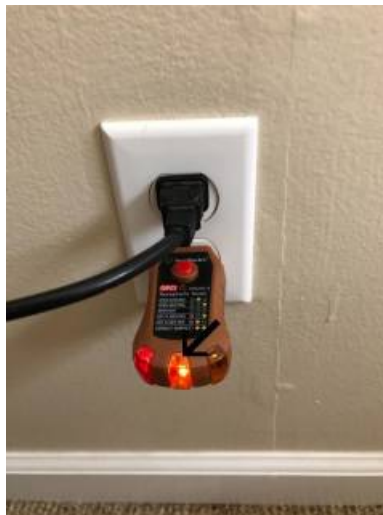
17.3 PHOTOS:

17.2 REPAIRS\COMMENTS: Hot & neutral reversed.

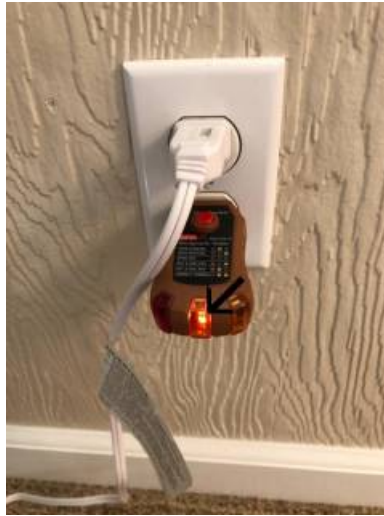
17.5 REPAIRS\COMMENTS: Open ground problem.

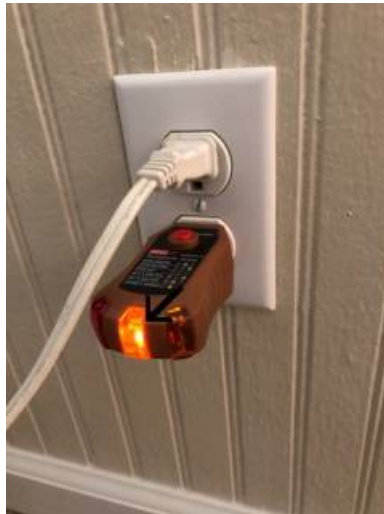
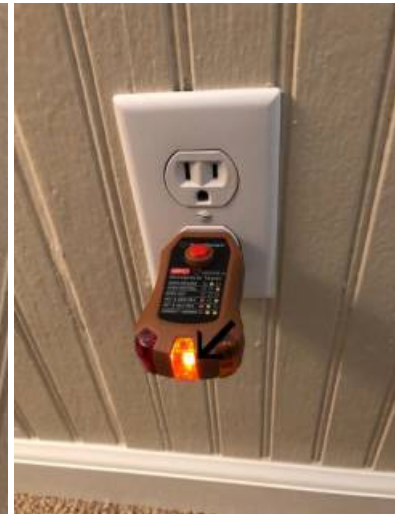
17.9 PHOTOS:

17.8 REPAIRS\COMMENTS: Open ground problem.

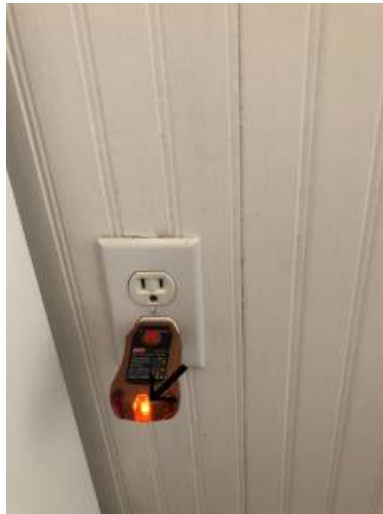
18.3 PHOTOS:

18.2 REPAIRS\COMMENTS: Open ground problem.

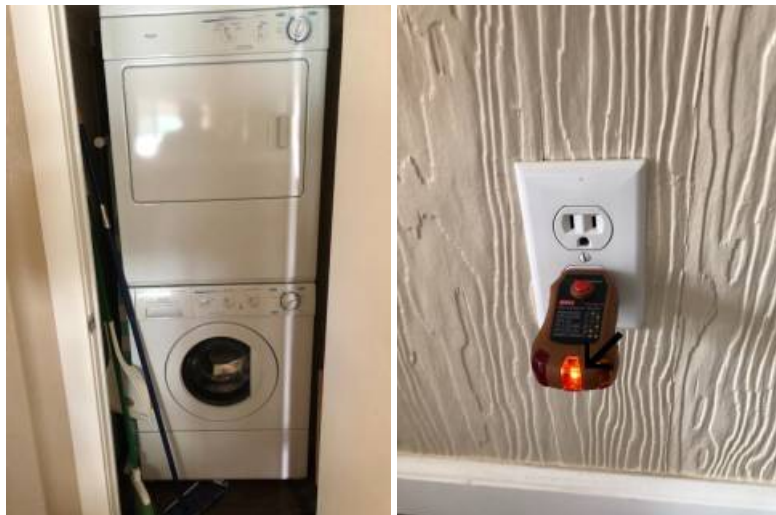
20.3 PHOTOS:

20.2 REPAIRS\COMMENTS: Includes washer & dryer. Also plug-in has a open ground problem.

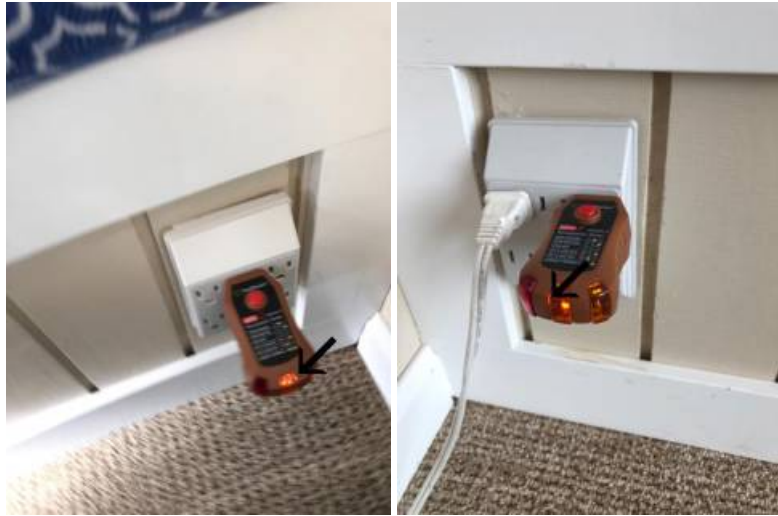
20.6 PHOTOS:

20.5 REPAIRS\COMMENTS: Open ground problem.

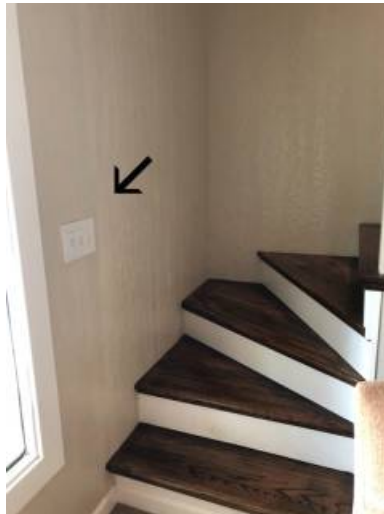
20.9 PHOTOS:

20.8 REPAIRS\COMMENTS: Code requires hand railing by bottom of steps.
