Craig Farmer Inspections, LLC

Inspection reference: Laurel Kerr 2020

Thursday, July 23, 2020

7286 Revilo Point Rd.
Hayden ID 83835

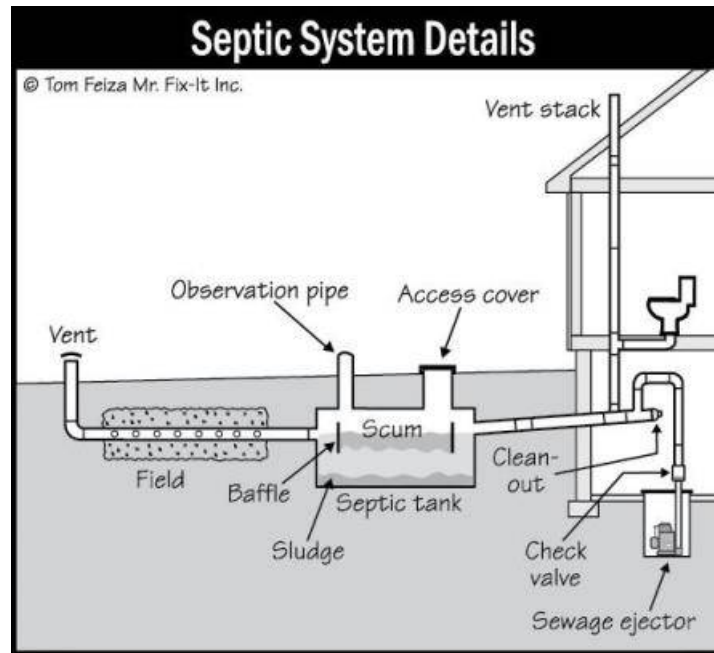
P121

Private, Septic tank was
pumped out in 2016.
Typically septic tanks need to
be pumped out every 5 years.
Even though it only has been
4 years I strongly suggest
pumping out septic tank and
inspecting septic tank for any
damage before sale property.

Recommend tank flushed and inspected by a certified Septic Contractor. Recommend a separate Home Energy Audit to determine utility cost savings.

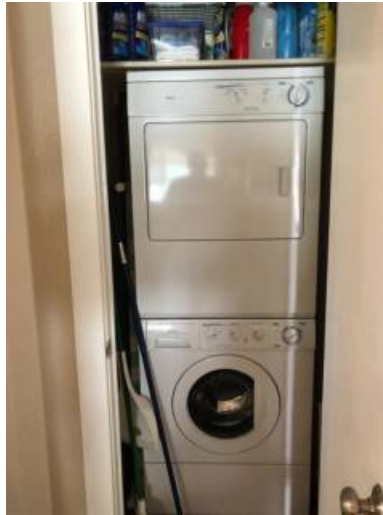
16.2 *REPAIRS\COMMENTS:* In closet in main hallway.
