Craig Farmer Inspections, LLC

Confidential Inspection Report

15632 Montrose Way
Caldwell ID 83607

October 1, 2018

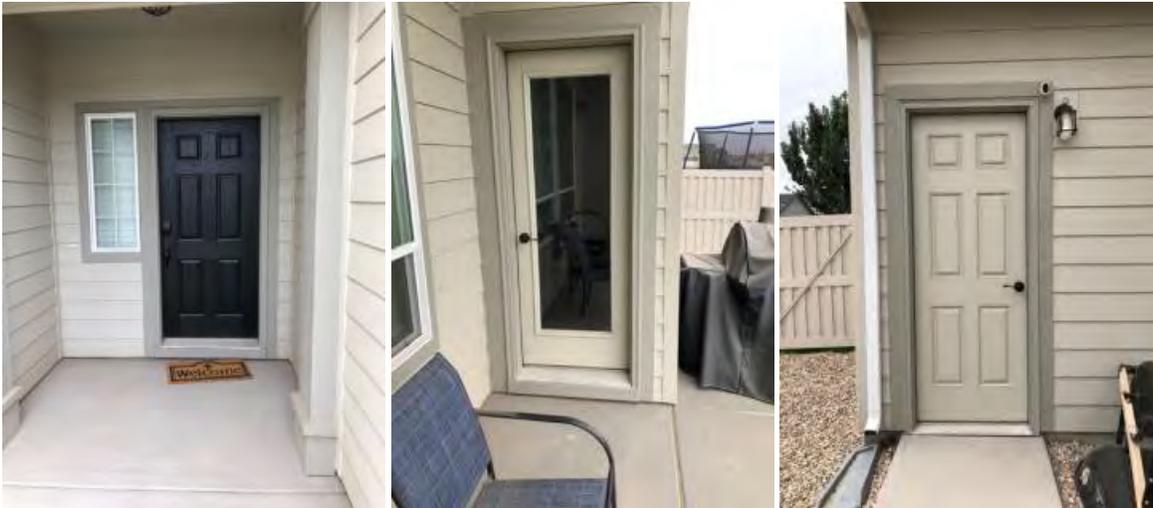
3.14 PHOTOS:

Good - The exterior siding materials are of a better grade or condition than I would normally expect to see. The siding is in serviceable condition.

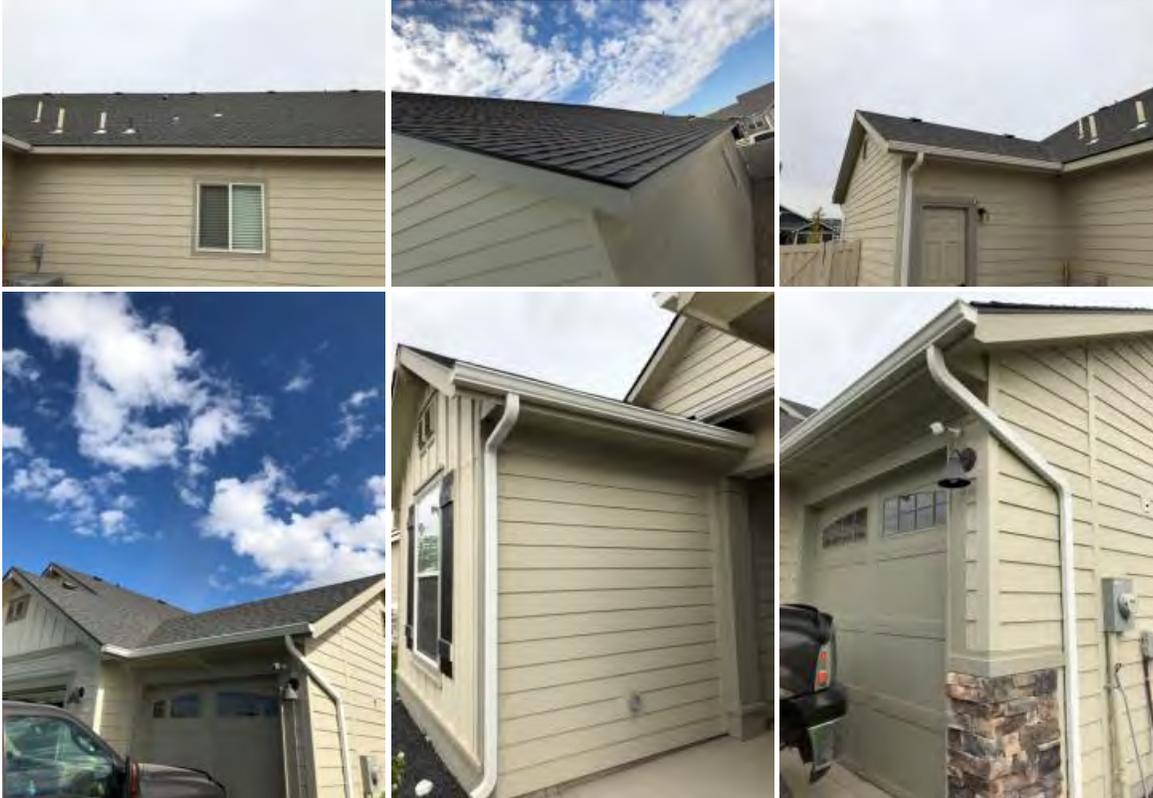
RECAP:**5.10 PHOTOS:**

Good - The roof covering material is either new or near new, and it appears to be installed correctly. The roof covering material is in a condition that is consistent with its age and method of installation, showing no deficiency or cause for immediate concern.

The gutter system on the roof edge appears to be functional and adequately sloped to carry the water to the downspouts.

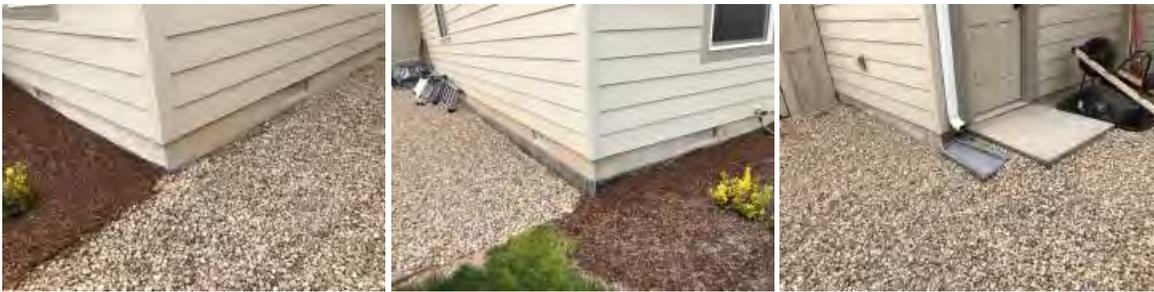
6.7 PHOTOS:

Raised Foundation with a crawlspace - Refers to a foundation wall with a footer below without a finished floor.

No visible cracking in the vertical foundation walls was noted during the exterior examination.

The drainage around the perimeter of the foundation appears to have adequate ground slope to remove run-off water from the immediate area.

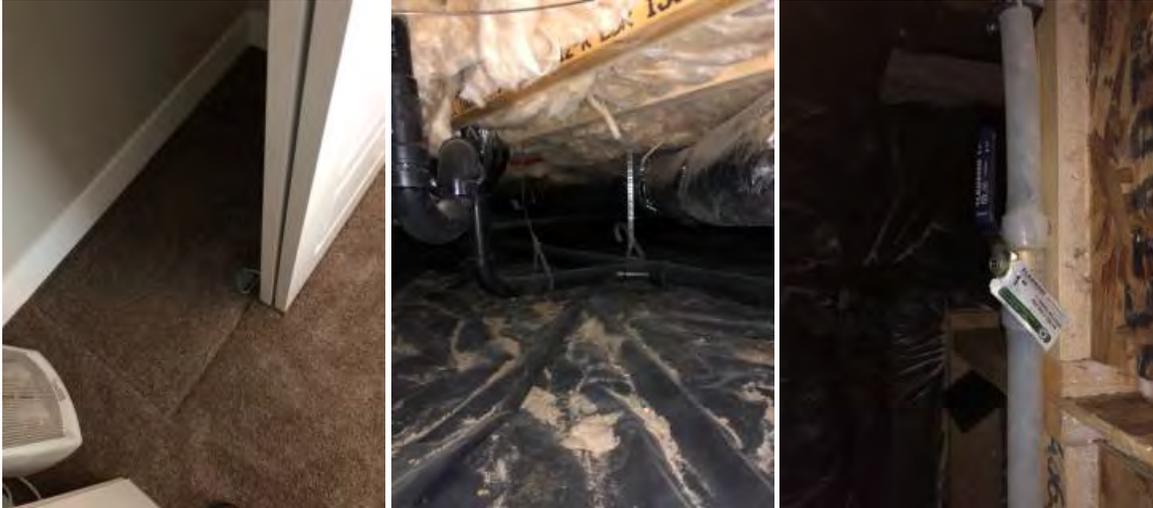
7.15 PHOTOS:

The exposed portions of the interior foundation perimeter walls appear to be adequate.

Yes - There is a vapor barrier installed. The floor is covered with an approved vapor/moisture retardant material.

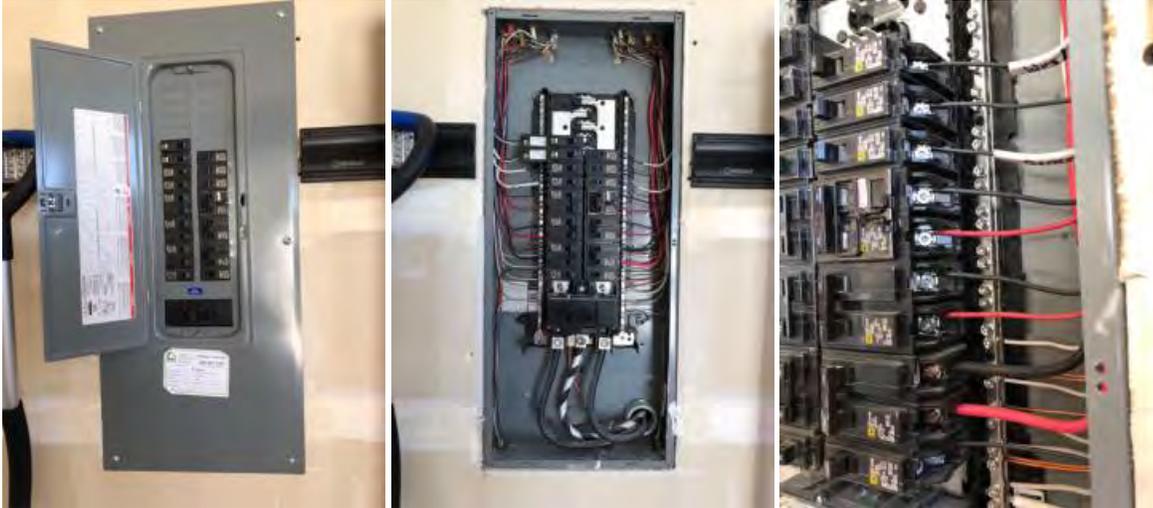
9.25 PHOTOS:

Main Inspection points of breaker box checked: General condition, matching breakers, empty spaces, double taps, proper ground, heat test & legends.

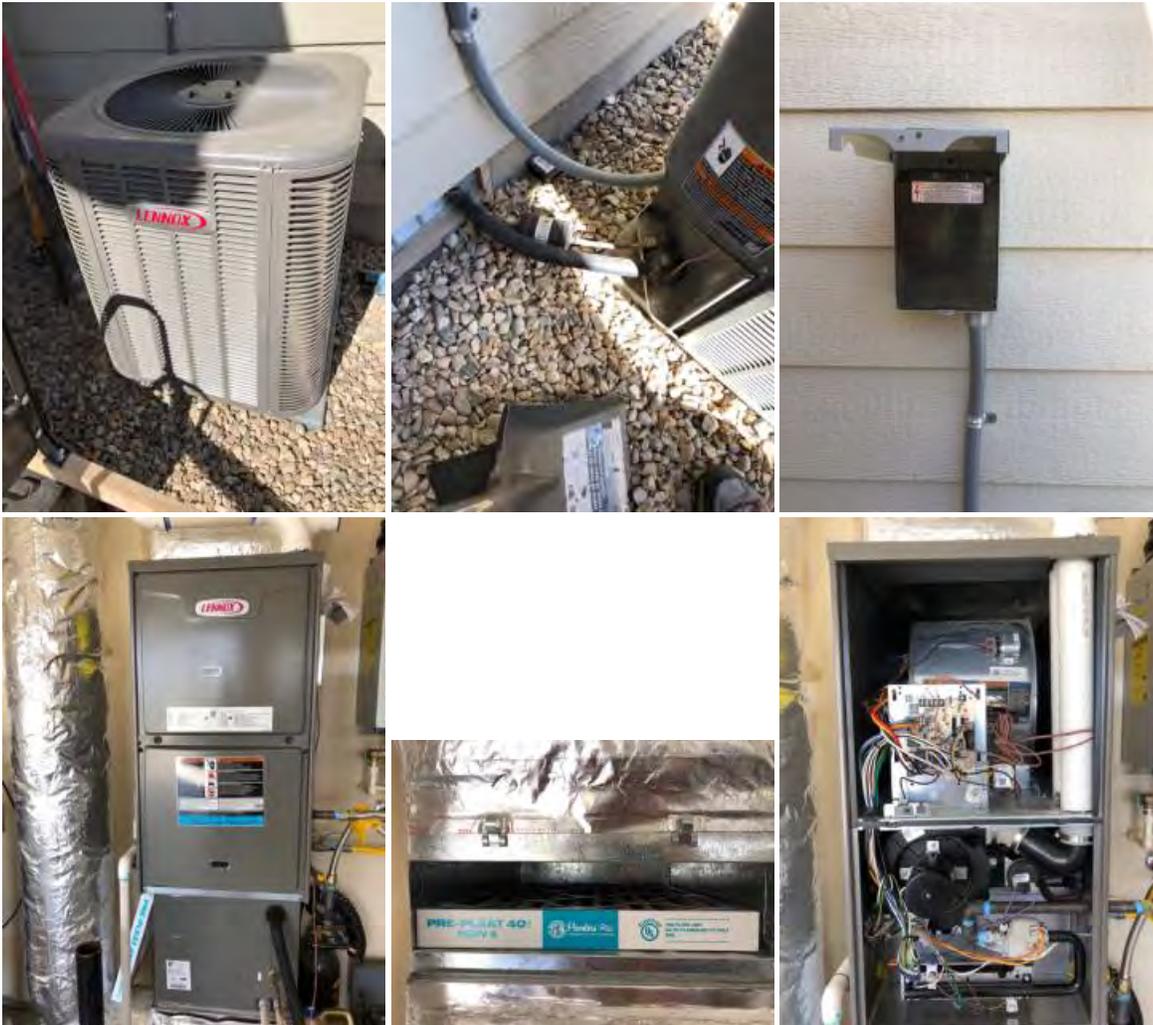
10.28 PHOTOS:

Replace Air Filter often for proper air flow for heat exchanger. Proper yearly Maintenance of heating, air conditioner and ducts are required to maintain proper life of each unit.

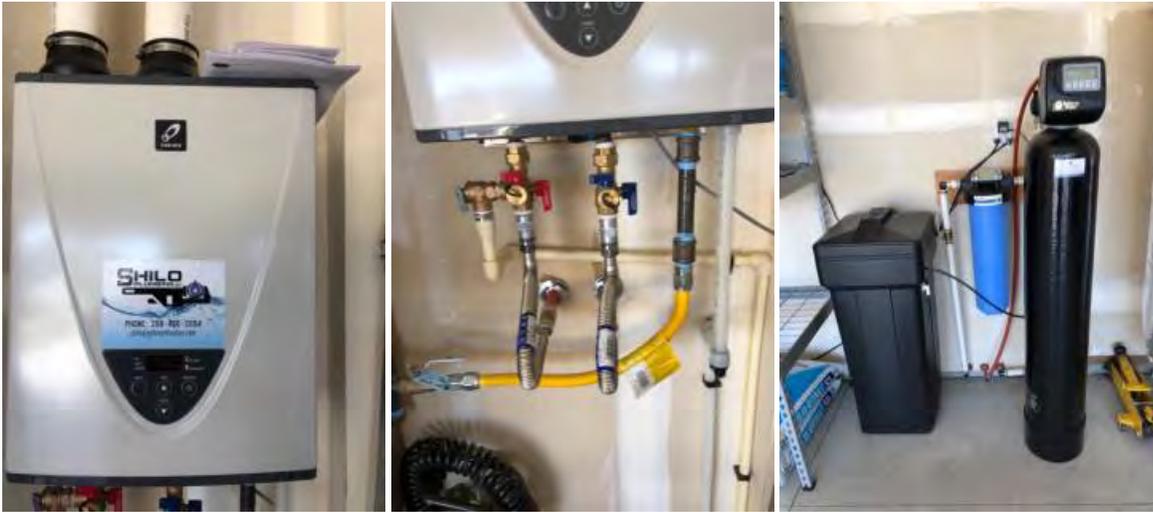
11.43 PHOTOS:

Main inspection points of water heater: corrosion/leaking, electrical connections, & TPR valve. Proper yearly Maintenance of Water Heaters are required to ensure proper life of units.

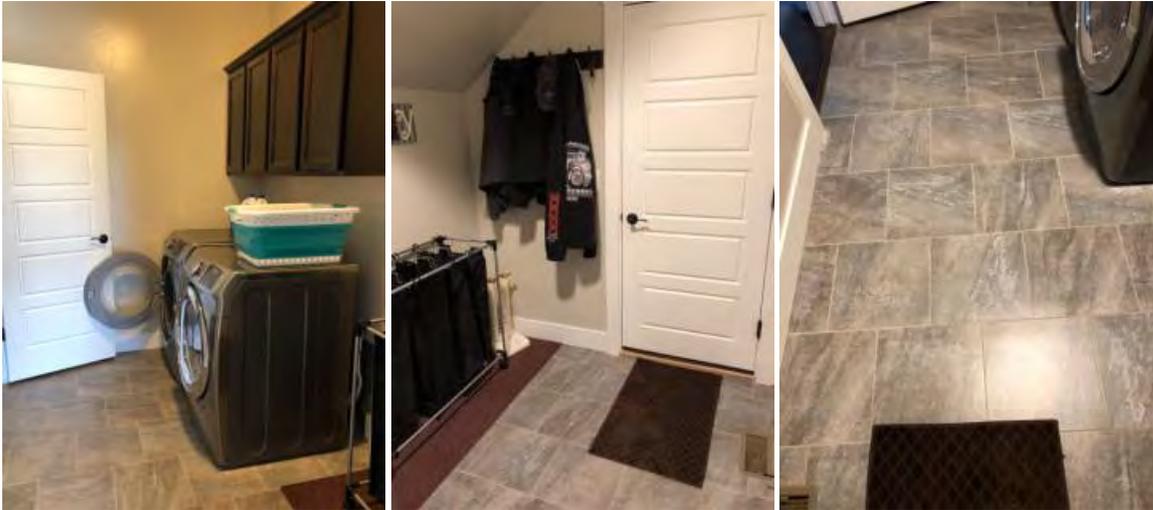
13.13 PHOTOS:

No - There is no washer pan installed under the washing machine. Any time the washing machine is installed on a floor level above another finished floor, a washer pan should be installed to prevent damage caused by an overflowing washer or a leak.

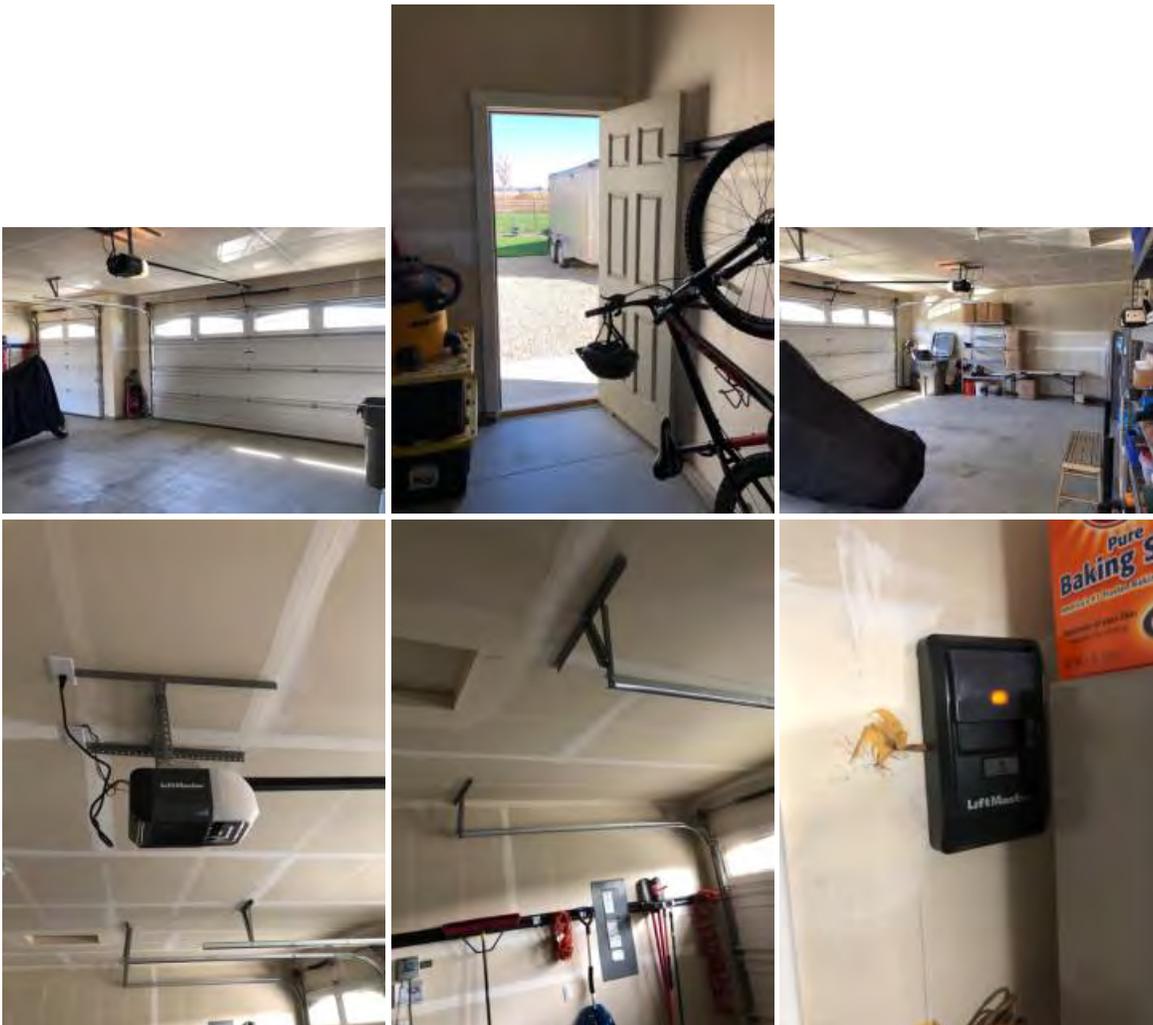
16.13 PHOTOS:

The overhead door is in satisfactory condition, and it is functional.

The visible portions of the foundation under the garage appear to be functional.

Attached to the house. The detached garage roof covering is in functional condition.
